## **APPENDIX B**

Photo Pages

Dixon Run Solar Project  
Route Evaluation Study

Roadway Photographs

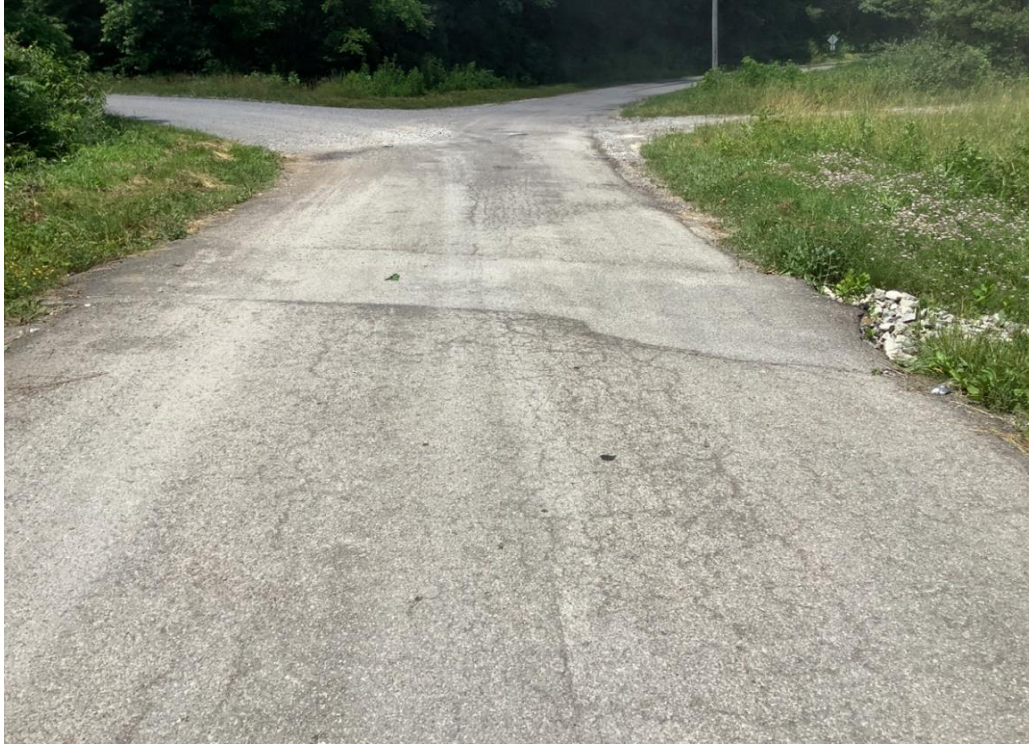
PHOTO 1: Pavement repair over culvert on Dixon Run Road, looking north.

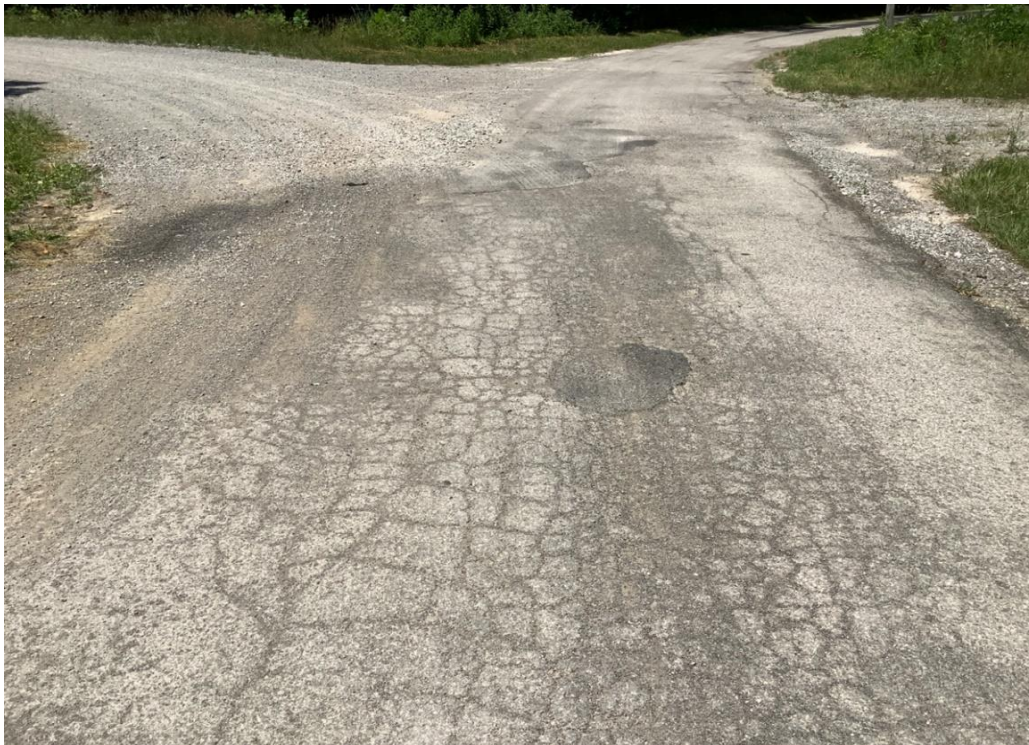
PHOTO 2: Typical pavement distress (alligator cracking and pothole repair) on Dixon Run Road, looking north.

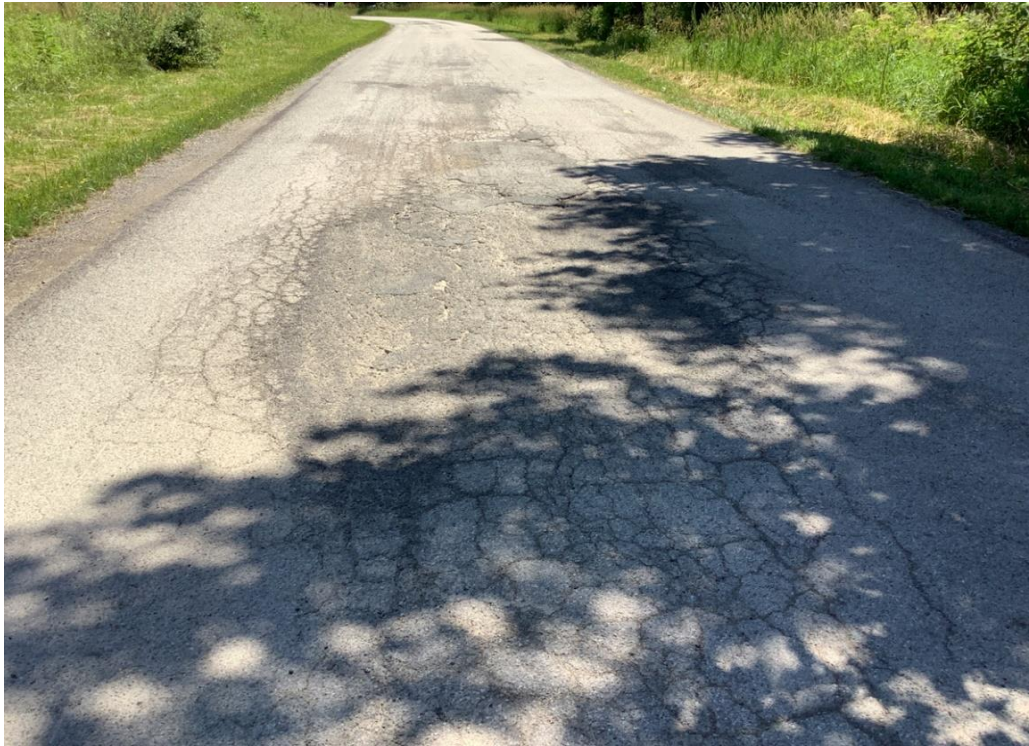
PHOTO 3: Pavement distress (severe pothole, cracking and base deterioration) on Dixon Run Road, looking south.

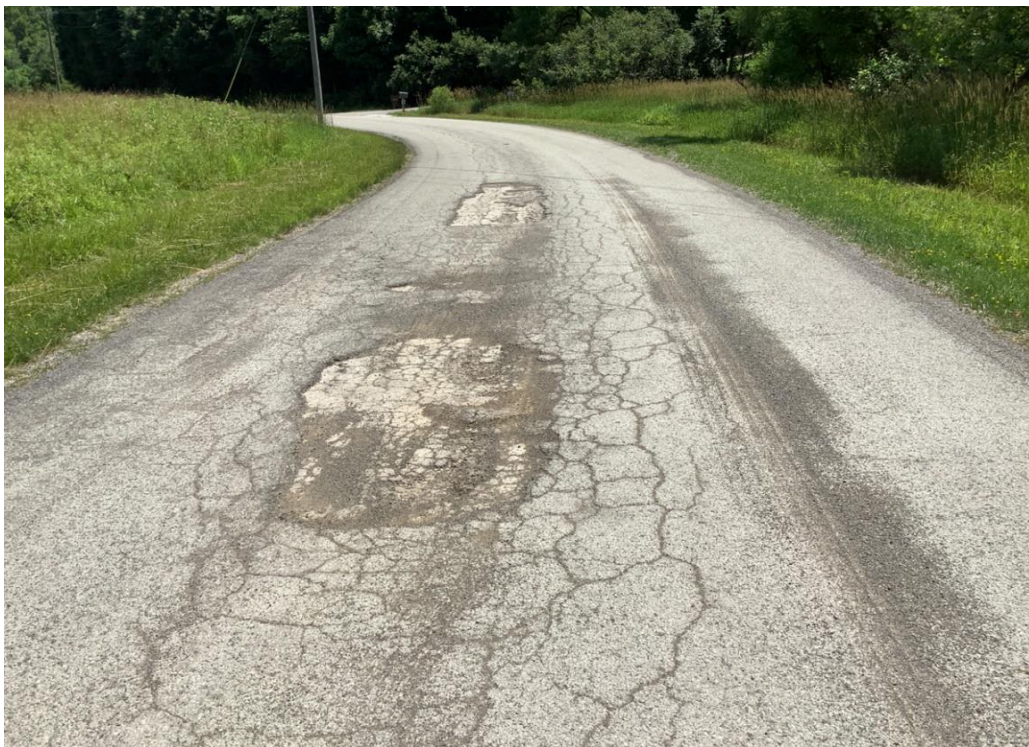
PHOTO 4: Pavement distress (severe pothole and delamination) on Dixon Run Road, looking south.

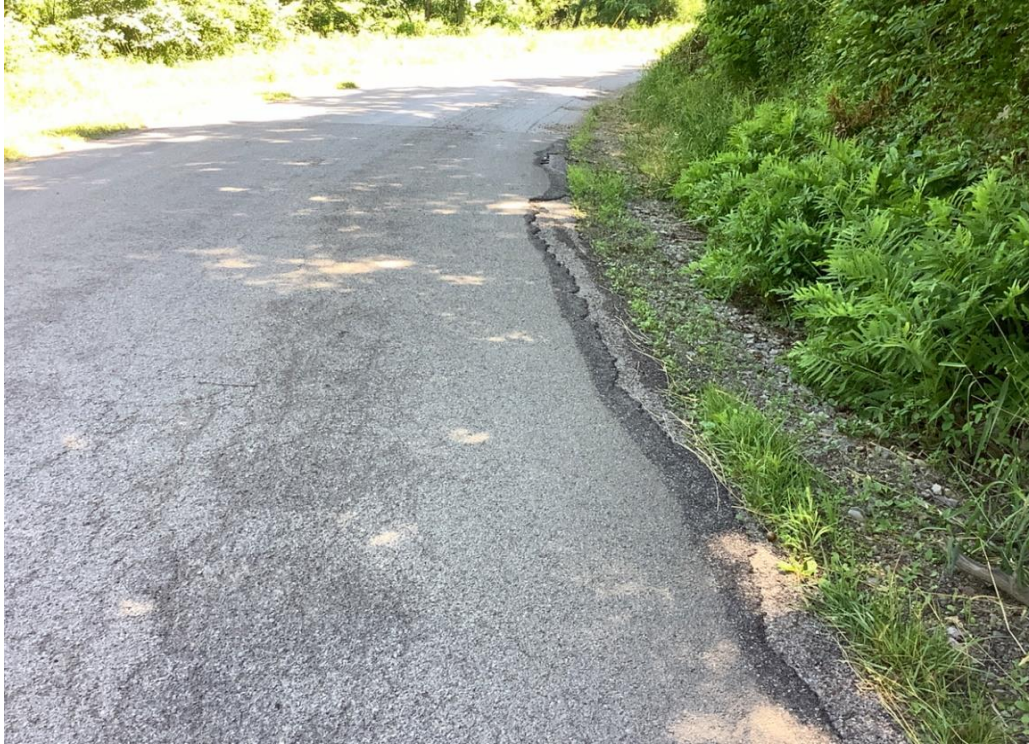
PHOTO 5: Pavement distress (edge deterioration) on Dixon Run Road, looking south.

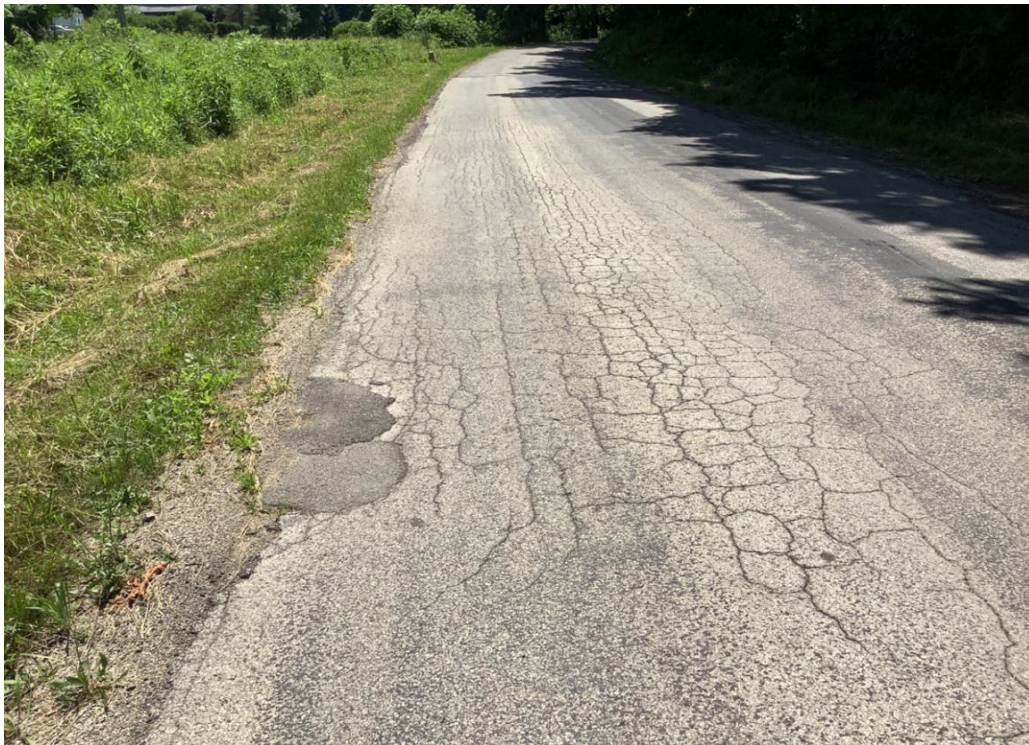
PHOTO 6: Pavement distress (alligator cracking and pothole repair) on Dixon Run Road, looking south.

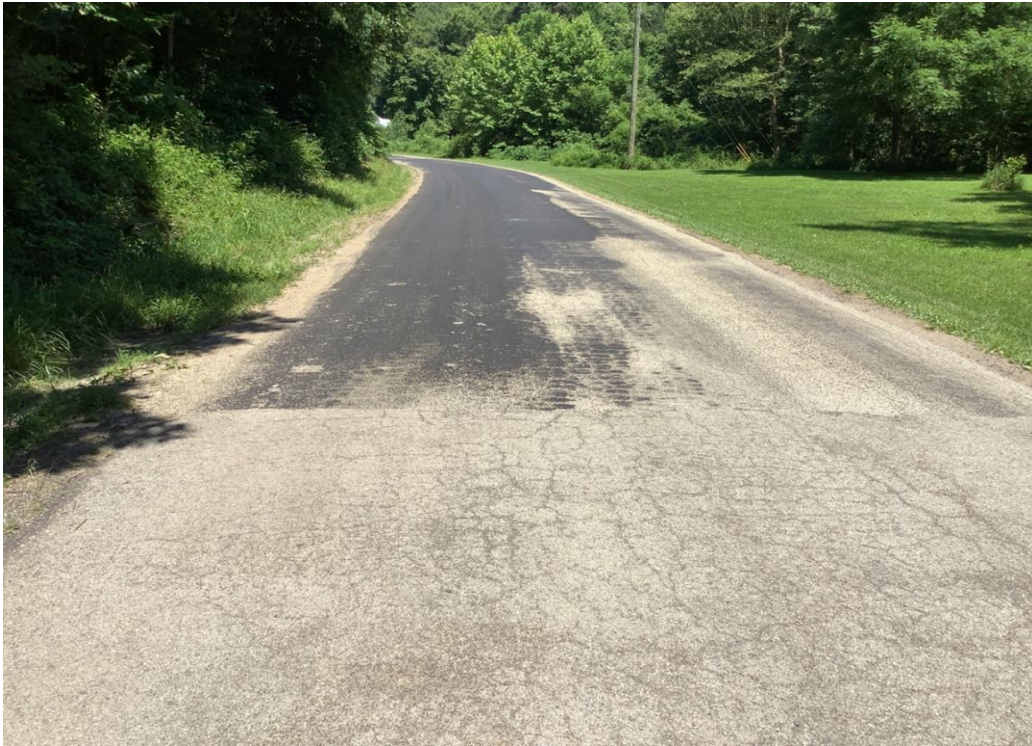
PHOTO 7: Pavement distress (severe bleeding) on Dixon Run Road, looking east.

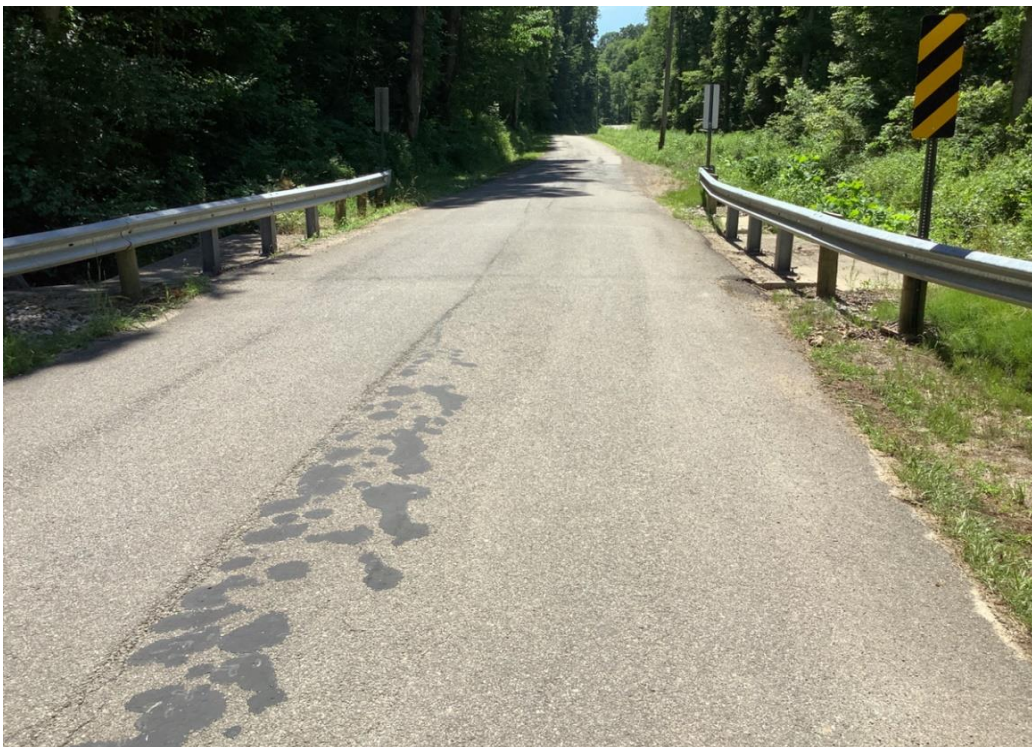
PHOTO 8: View of pavement over Bridge 4034016, looking west.

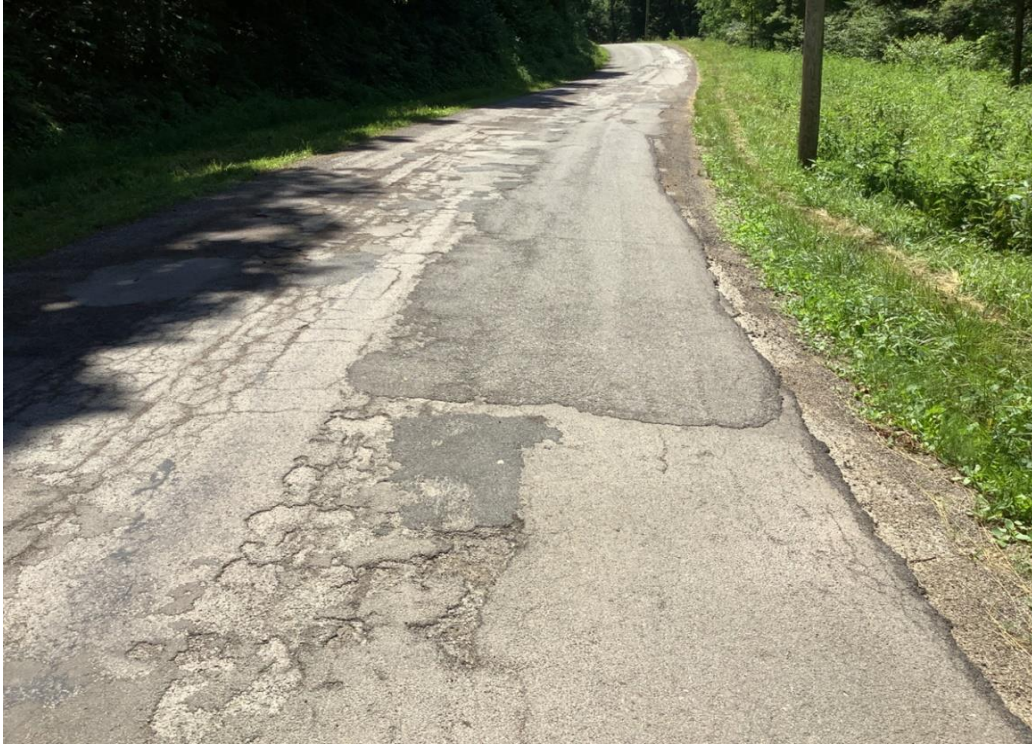
PHOTO 9: Pavement distress (severe pothole, alligator cracking, delamination, edge failure, and patching) on Dixon Run Road, looking west.

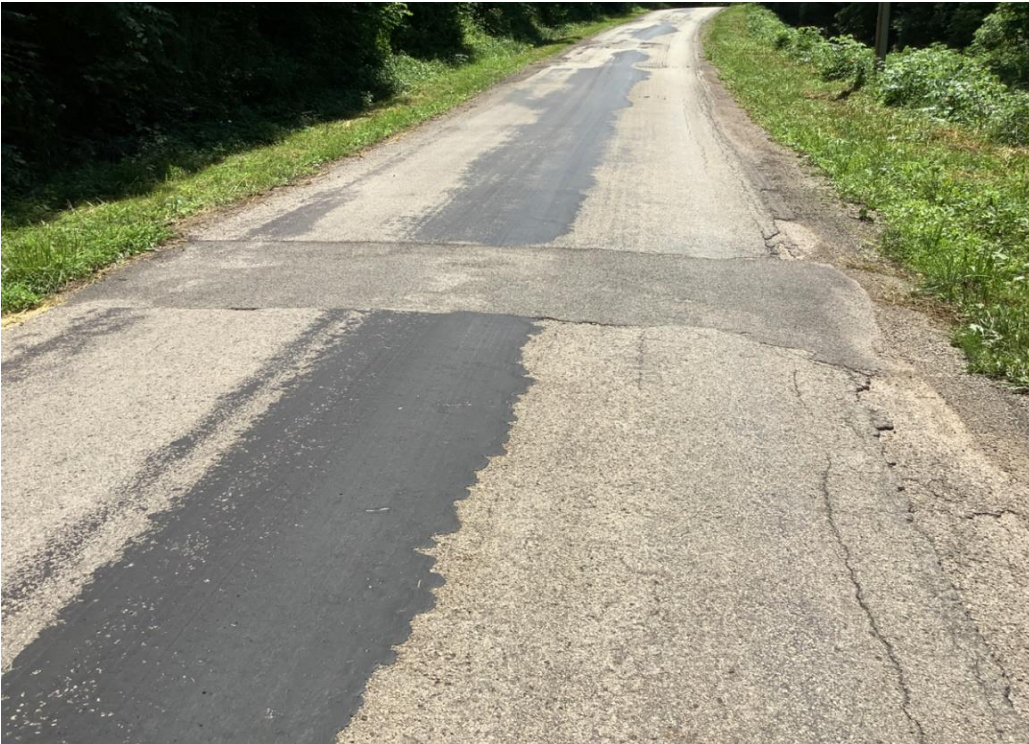
PHOTO 10: Pavement repair over culvert on Dixon Run Road, looking south.

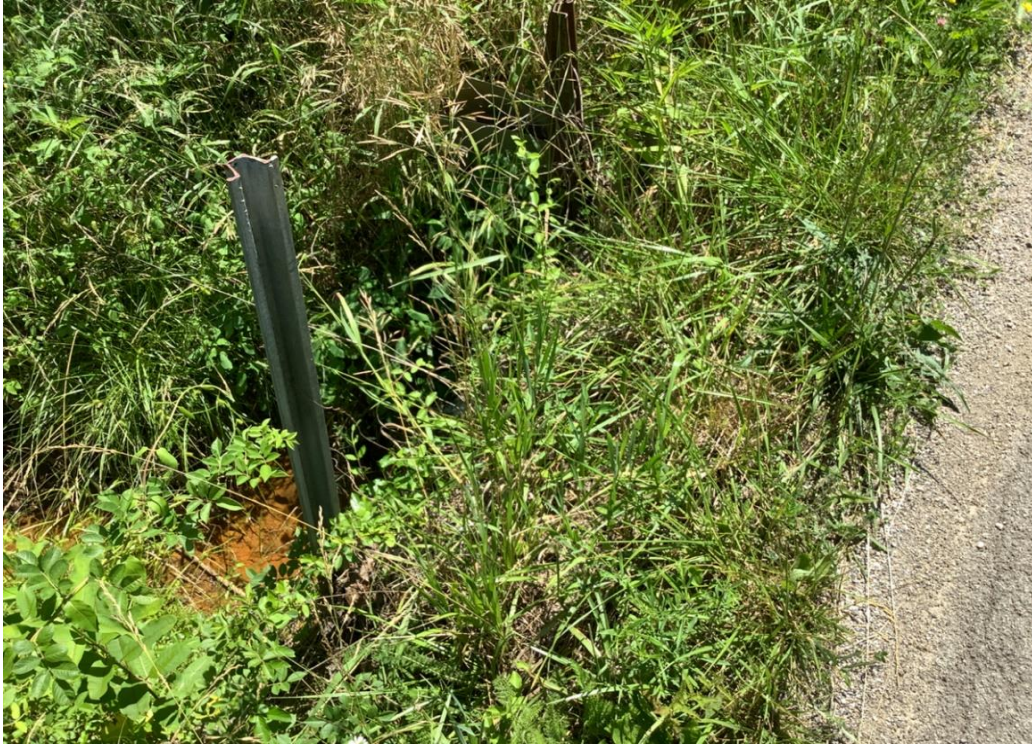
PHOTO 11: Embankment erosion on south end of culvert on Dixon Run Road, looking west.

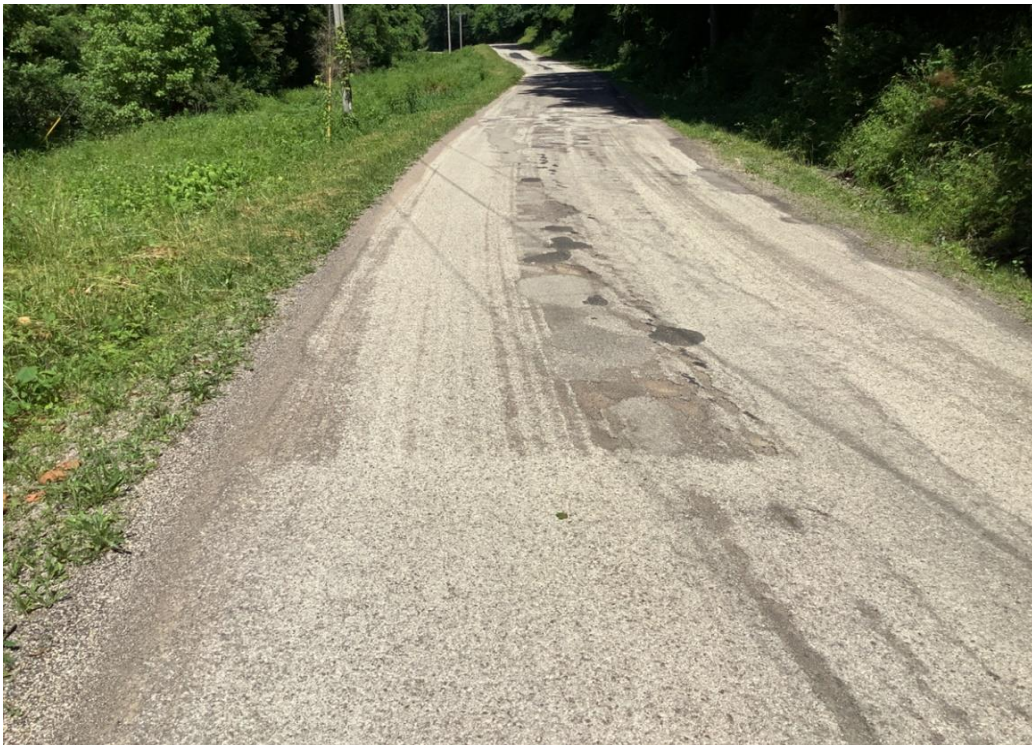
PHOTO 12: Pavement distress (severe delamination, potholes and patching) on Dixon Run Road, looking east.

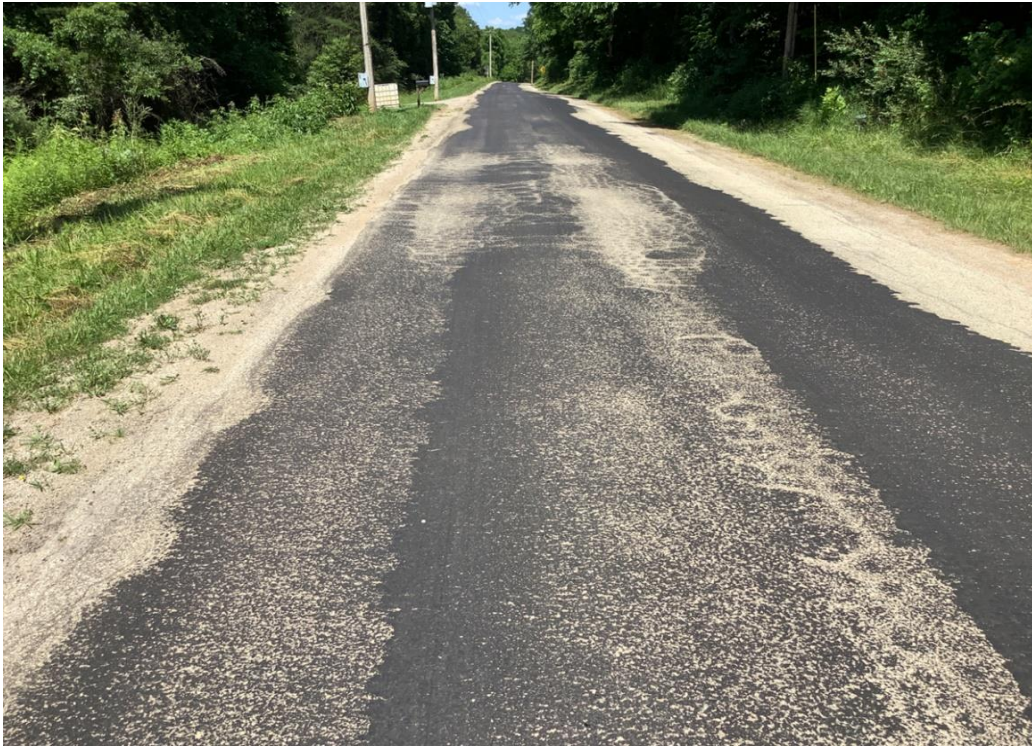
PHOTO 13: Pavement distress (severe rutting and bleeding) on Dixon Run Road, looking north.

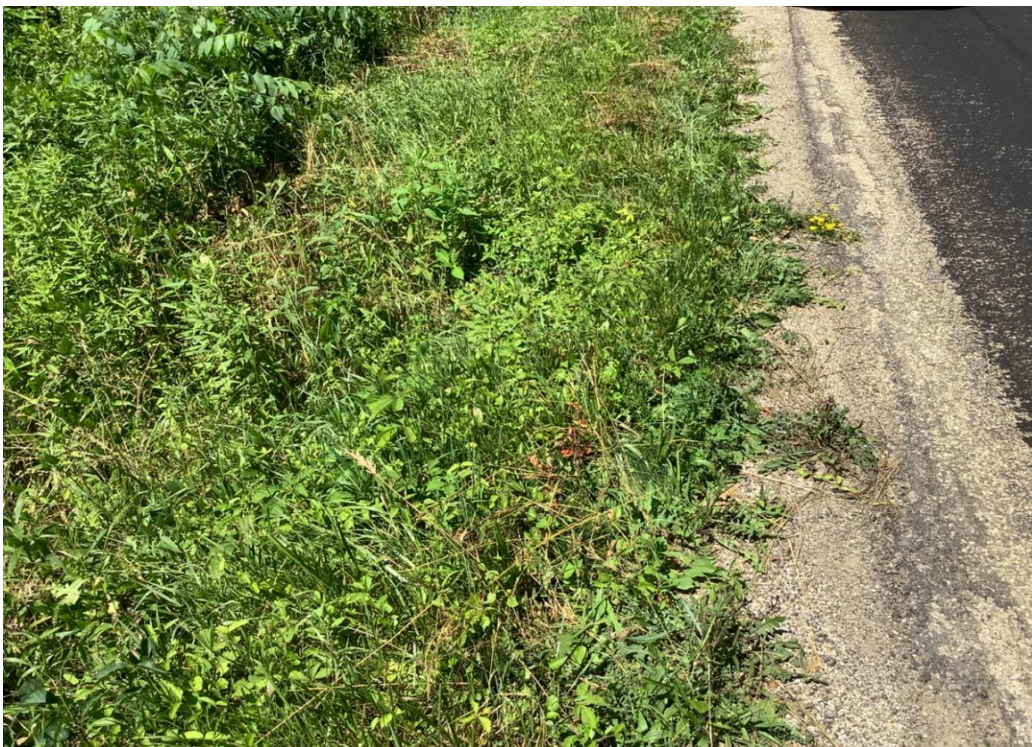
PHOTO 14: Embankment erosion on west side of pavement on Dixon Run Road, looking north.

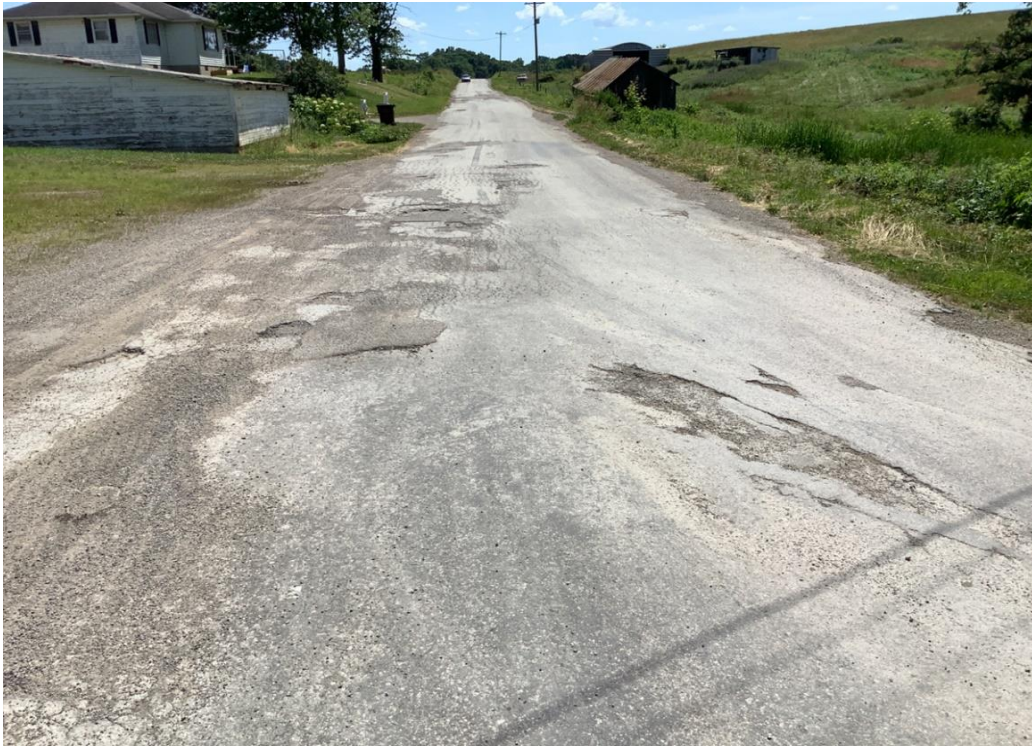
PHOTO 15: Pavement distress (severe pothole, alligator cracking, rutting, and patching) on Dixon Run Road, looking south.

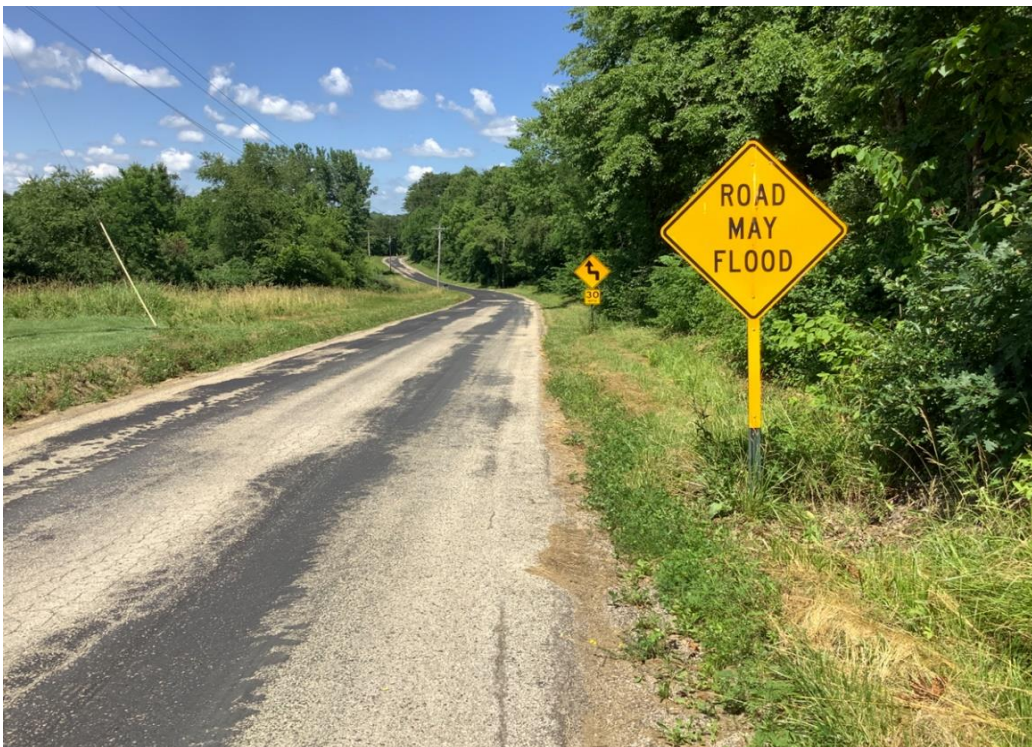
PHOTO 16: Caution sign on Dixon Run Road, looking north.

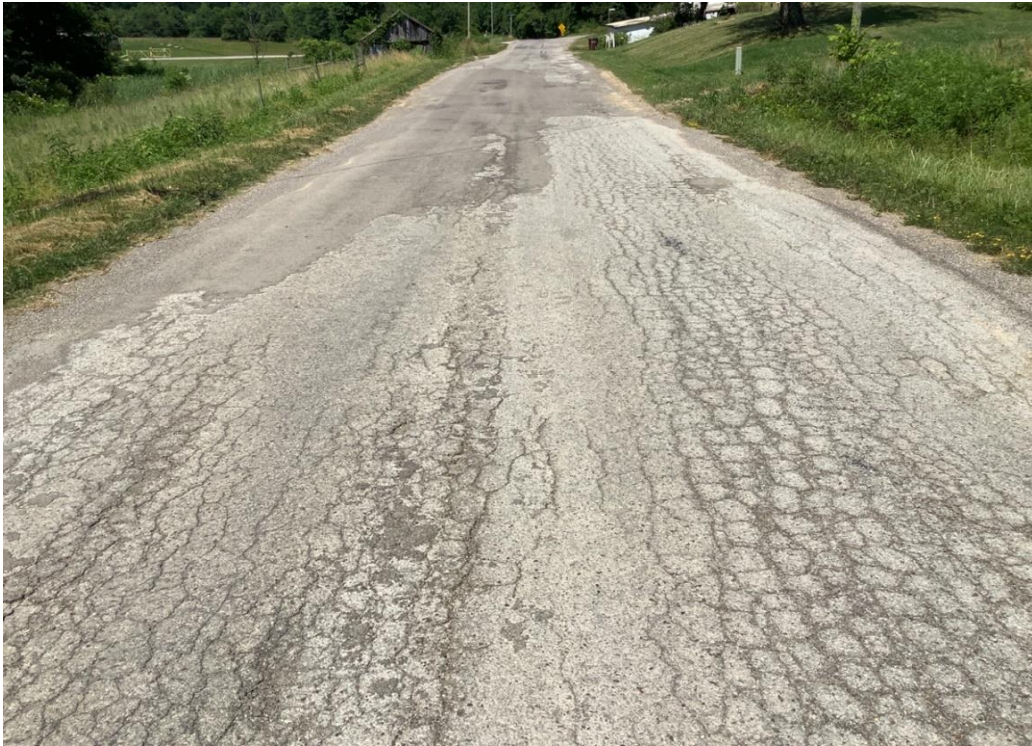
PHOTO 17: Pavement distress (severe alligator cracking and patching) on Dixon Run Road, looking north.

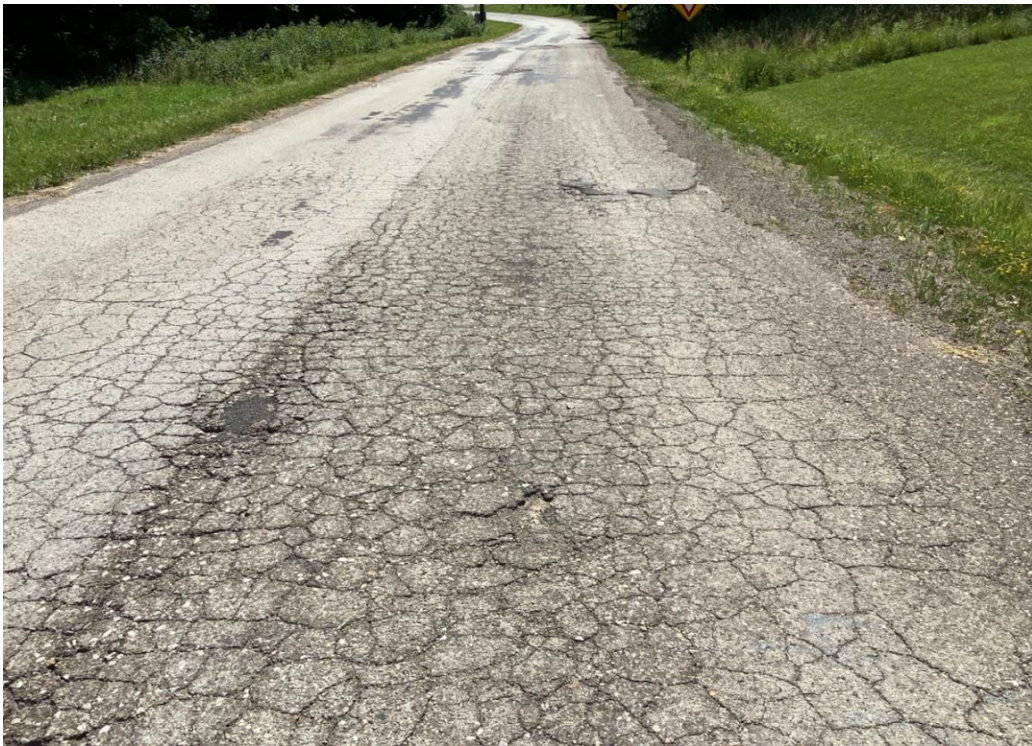
PHOTO 18: Pavement distress (severe alligator cracking and edge failure) on Dixon Run Road, looking south.

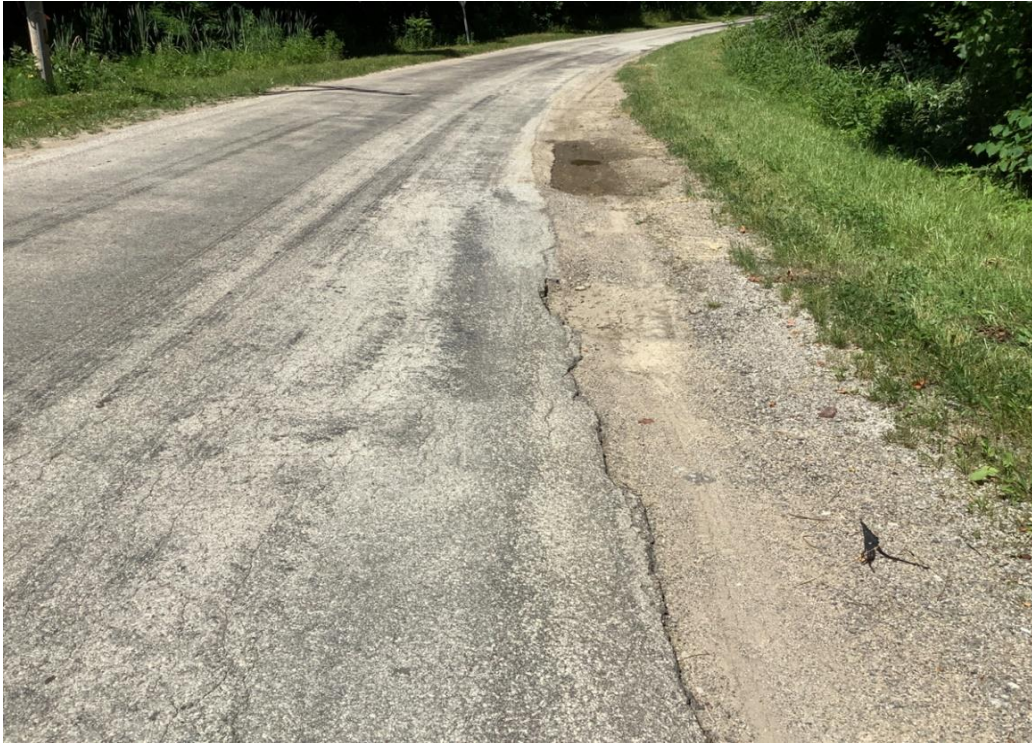
PHOTO 19: Pavement distress (edge and shoulder failure) on Dixon Run Road, looking north.

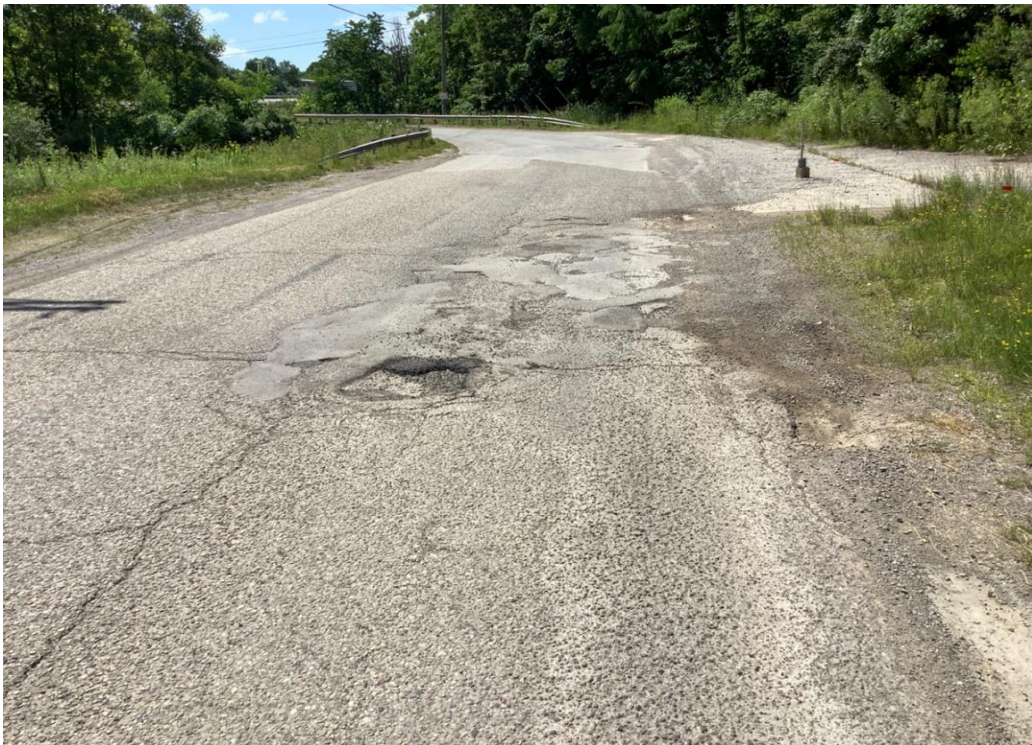
PHOTO 20: Pavement distress (severe pothole, alligator cracking, delamination, edge failure, and patching) on Dixon Run Road, looking west.

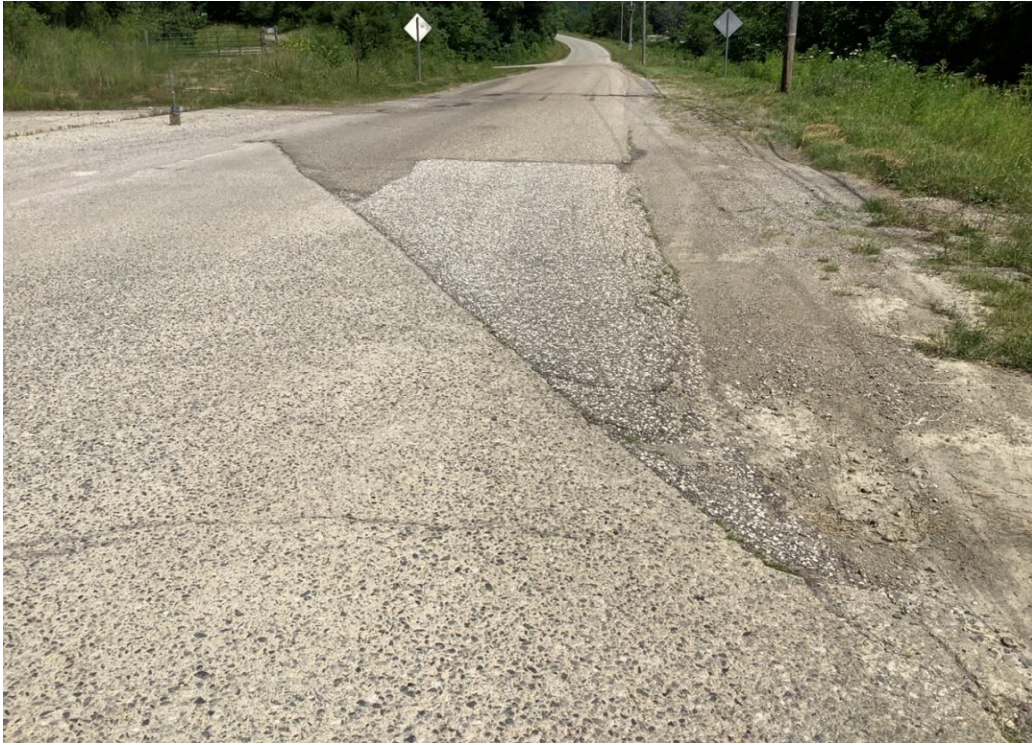
PHOTO 21: Transition from concrete pavement to asphalt pavement on Dixon Run Road, looking east.

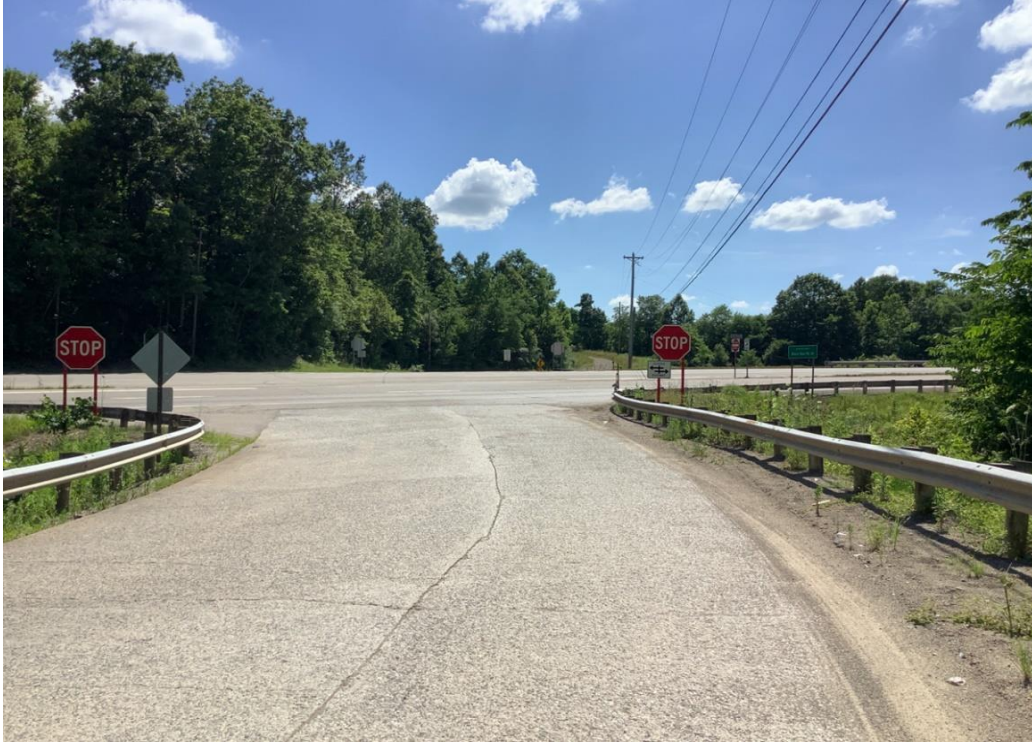
PHOTO 22: Pavement over Bridge 4000668 on Dixon Run Road and intersection with US35, looking west.

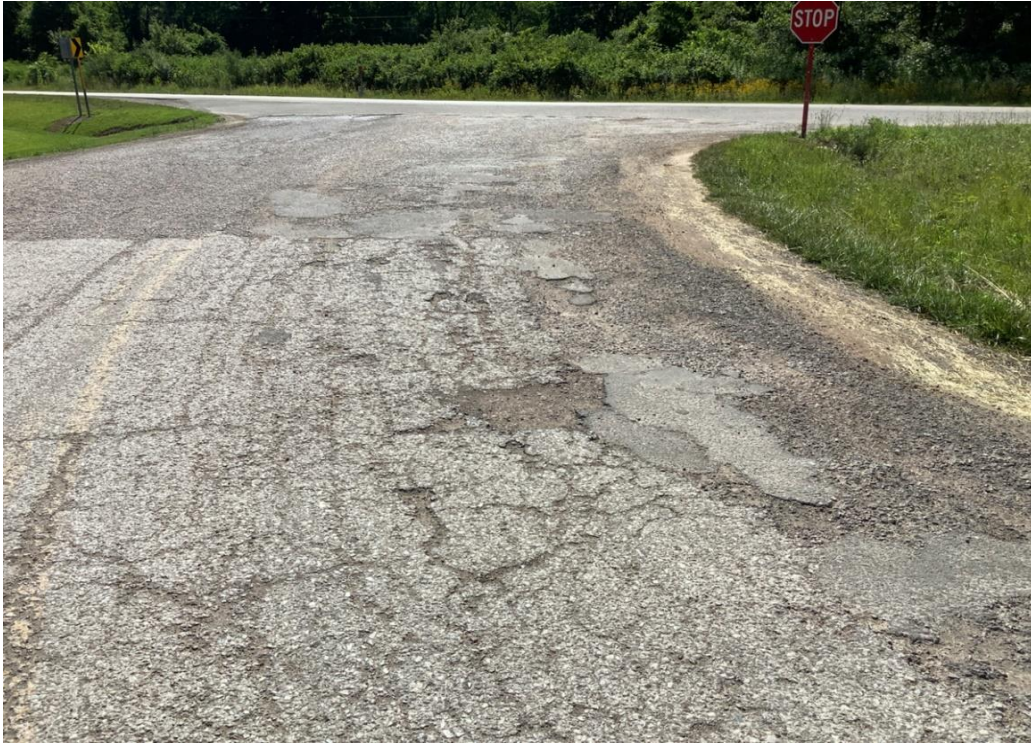
PHOTO 23: Pavement distress (severe delamination, raveling, and patching) on Keystone Furnace Road, looking west.

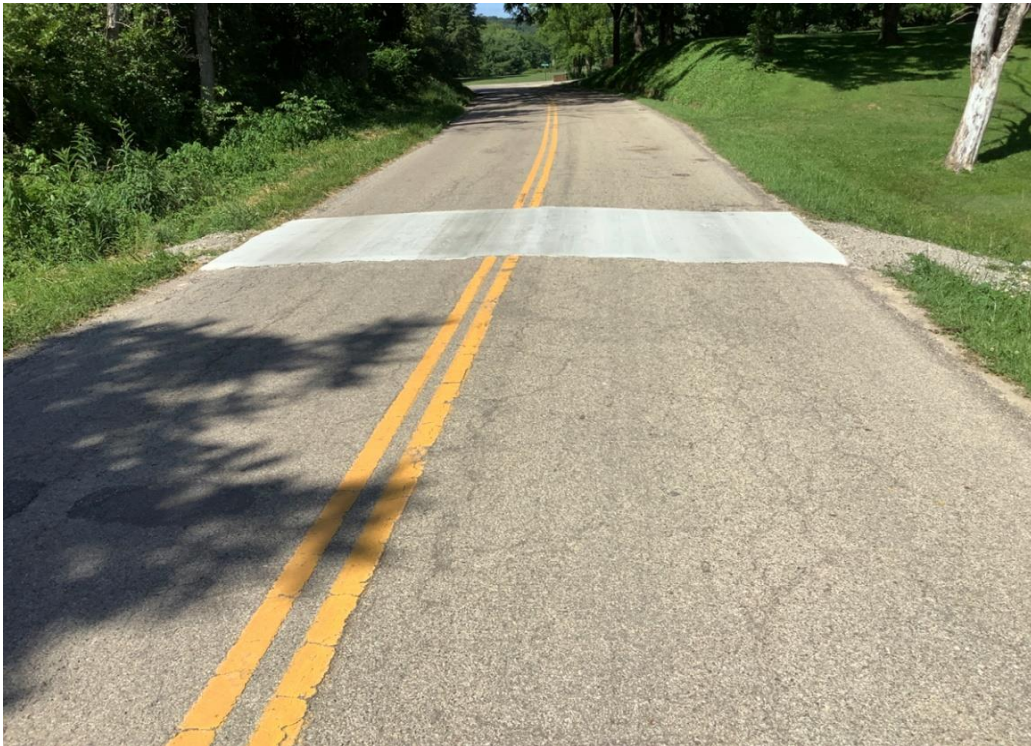
PHOTO 24: Pavement repair over culvert on Keystone Furnace Road, looking north.

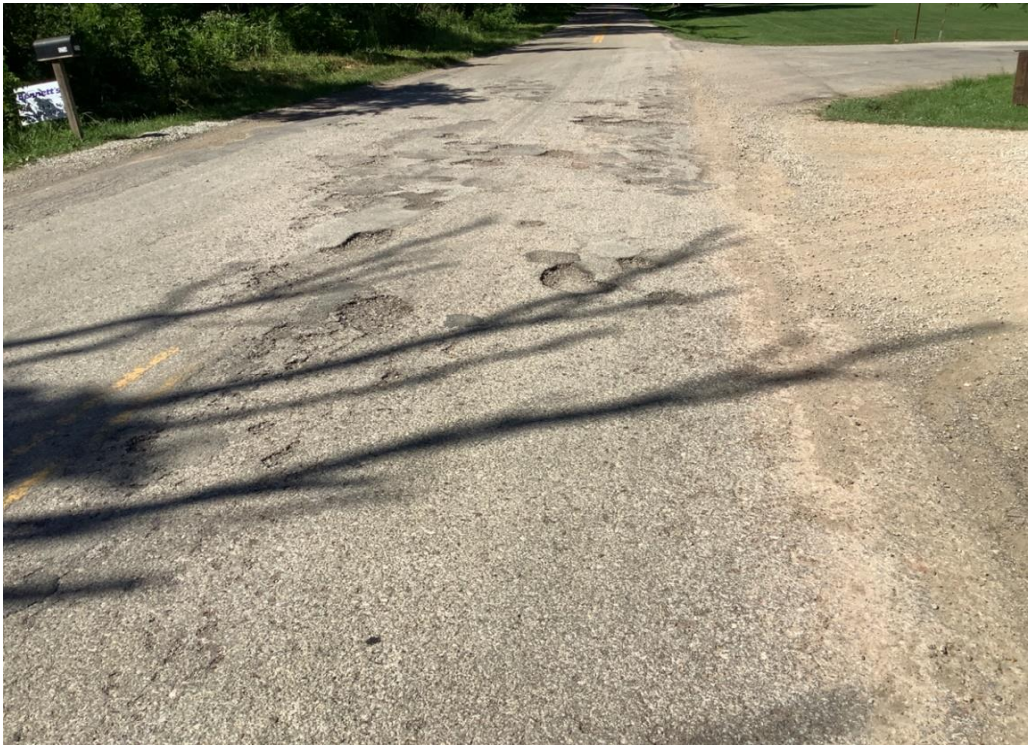
PHOTO 25: Pavement distress (severe delamination, potholes, and patching) on Keystone Furnace Road, looking north.

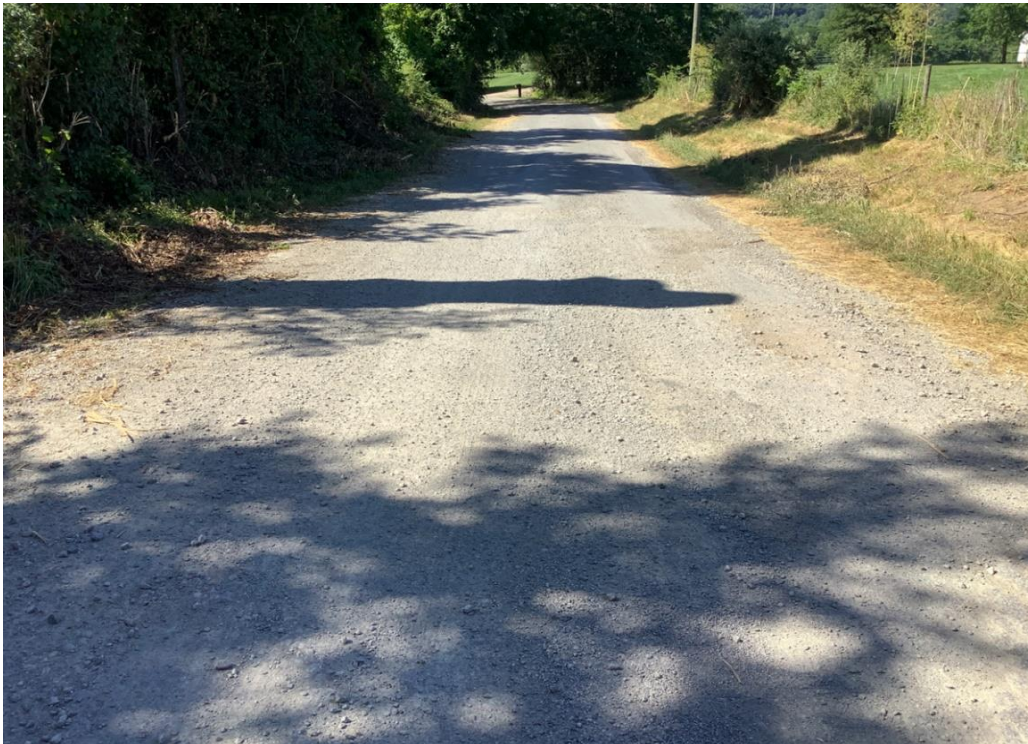
PHOTO 26: Typical pavement distress (potholes, rutting and gravel-filled potholes) for asphalt section of Luther Jones Road, looking north.

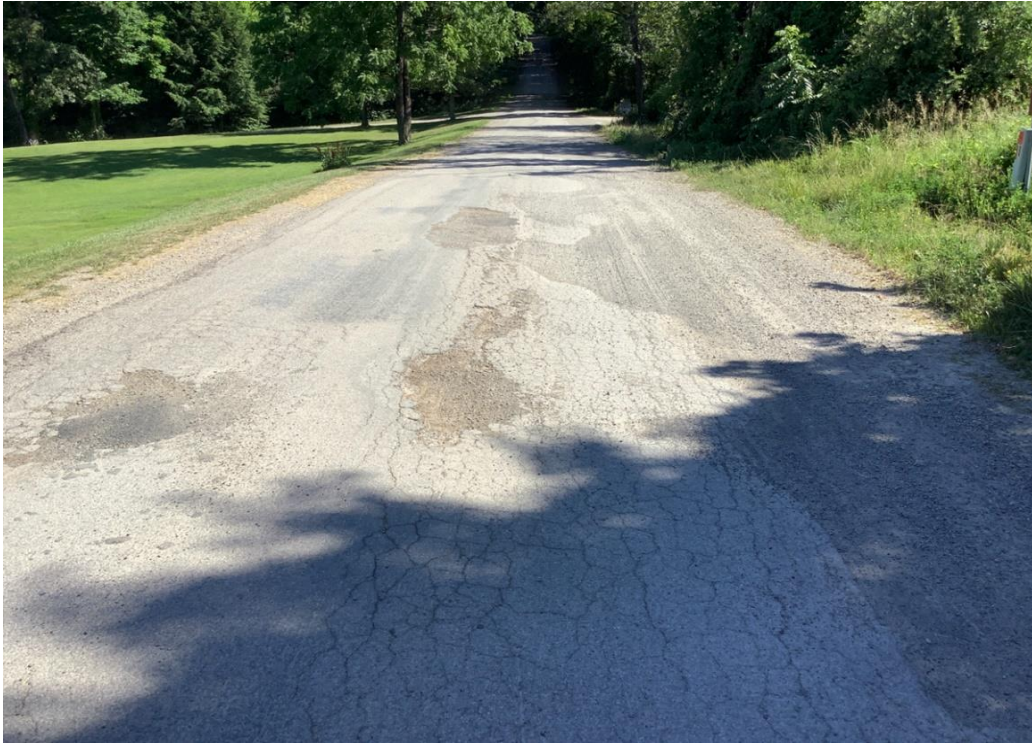
PHOTO 27: Typical pavement distress (severe rutting, alligator cracking, and gravel-filled potholes) for asphalt section of Luther Jones Road, looking south.

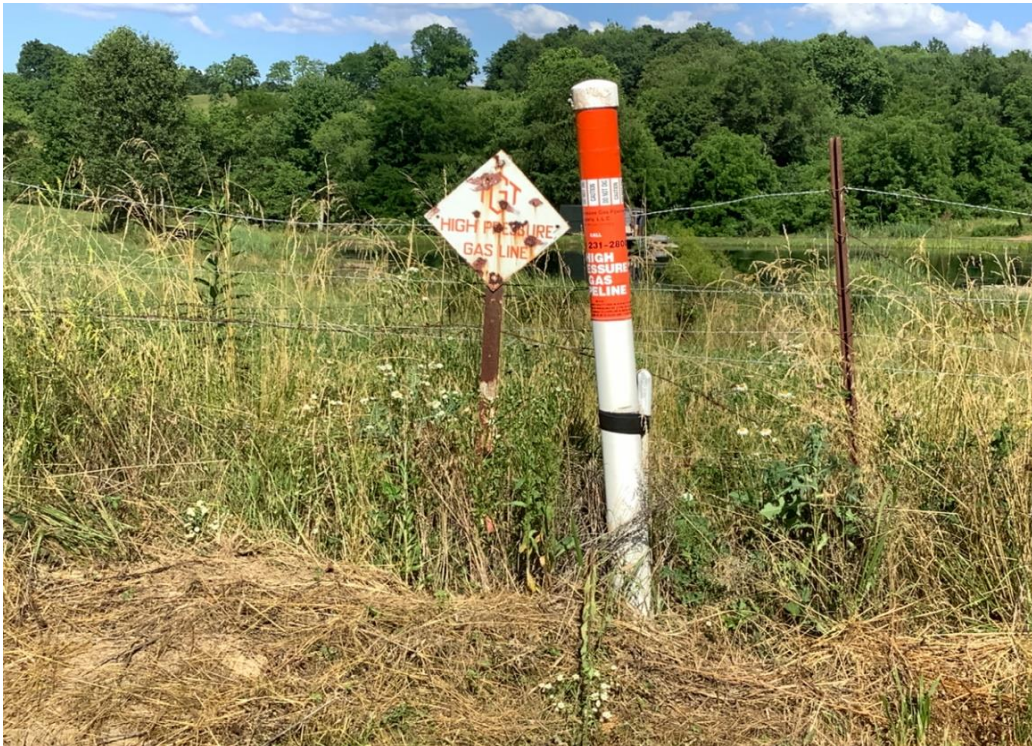
PHOTO 28: Underground high-pressure gas line marker on Luther Jones Road, looking east.

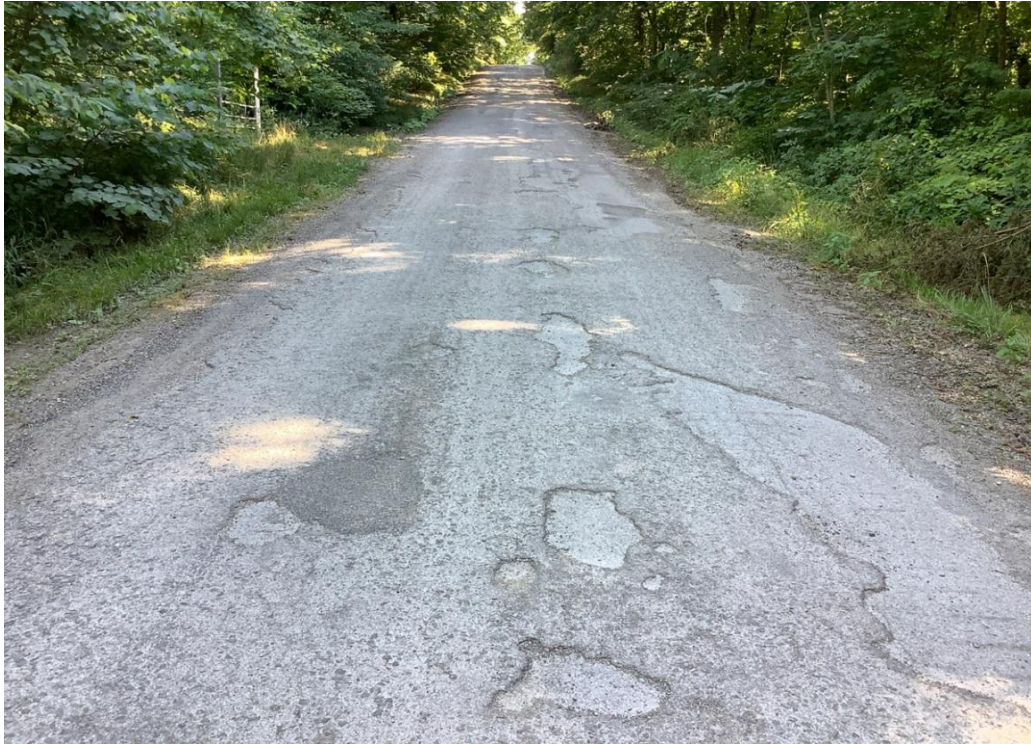
PHOTO 29: Typical pavement distress (severe delamination and edge failure) for asphalt section of Luther Jones Road, looking south.
