## **APPENDIX B**

Photo Pages

Dixon Run Solar Project  
Route Evaluation Study

Roadway Photographs

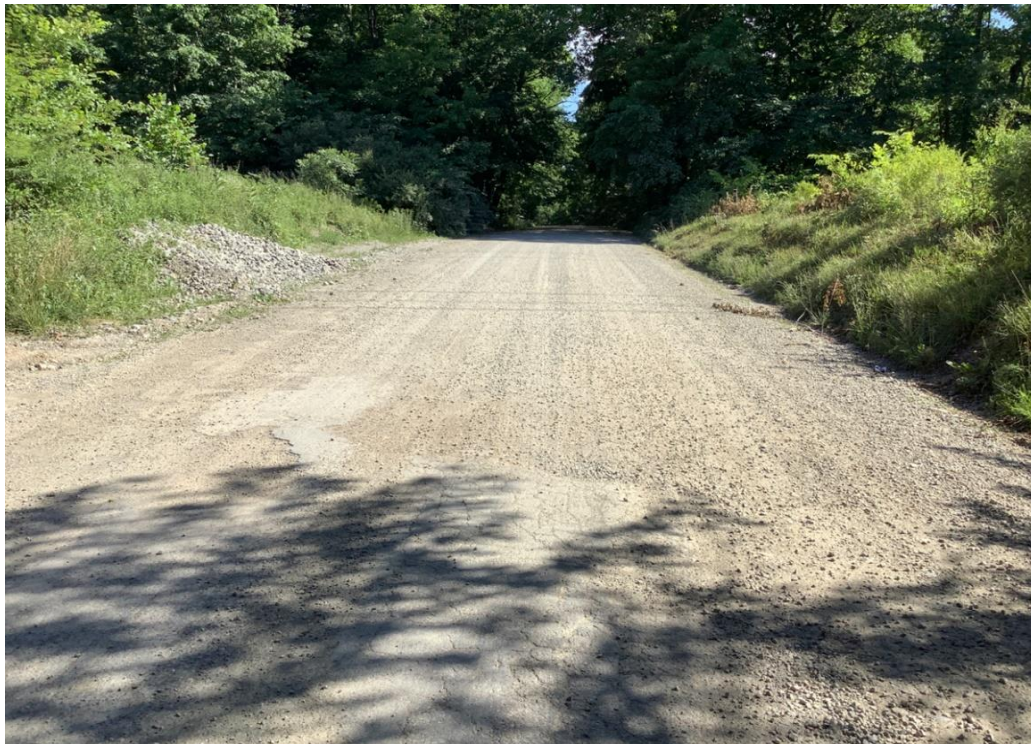
PHOTO 30: Transition from asphalt pavement to aggregate pavement on Luther Jones Road, looking south.

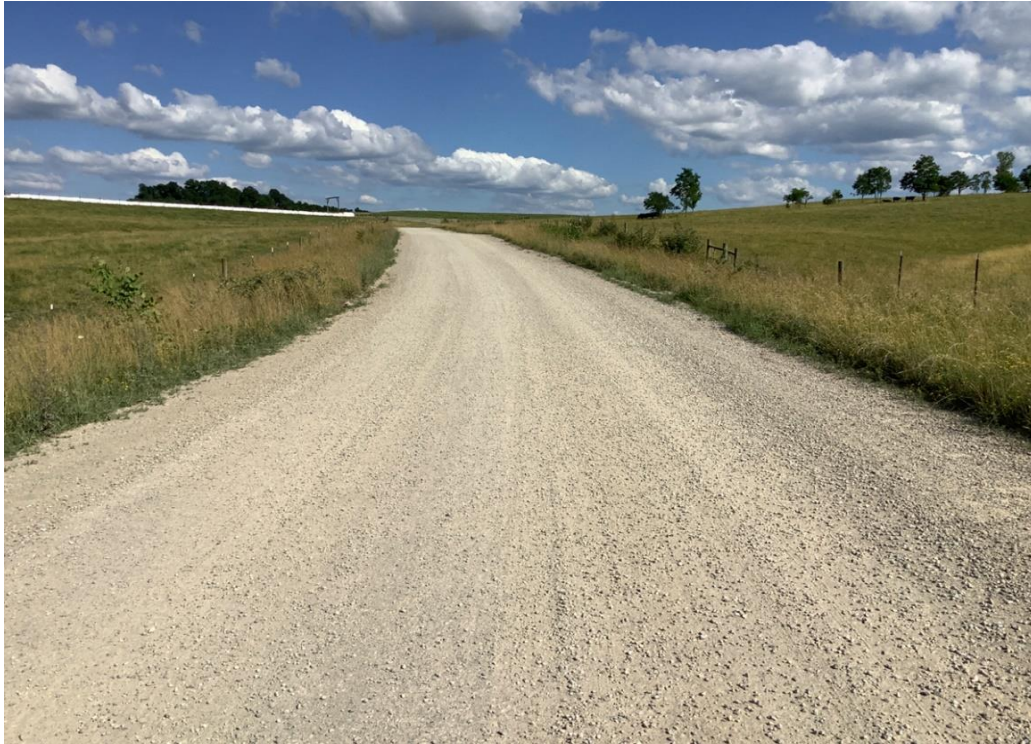
PHOTO 31: Typical aggregate pavement section of Luther Jones Road, looking east.

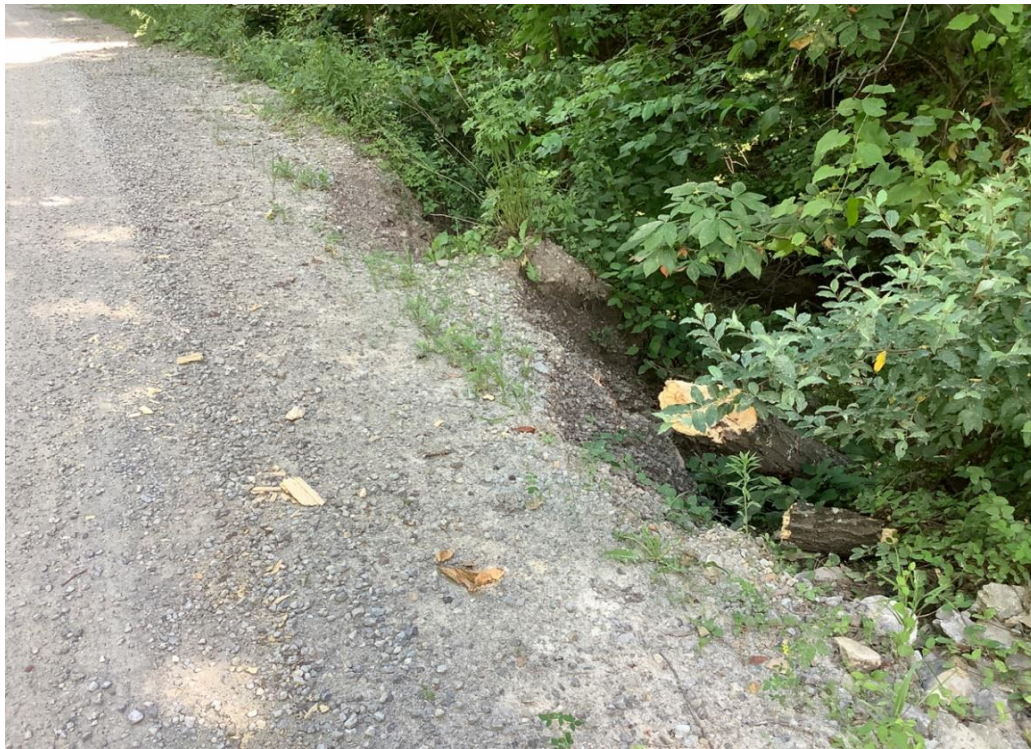
PHOTO 32: Localized embankment erosion on south side of pavement on Luther Jones Road, looking south.

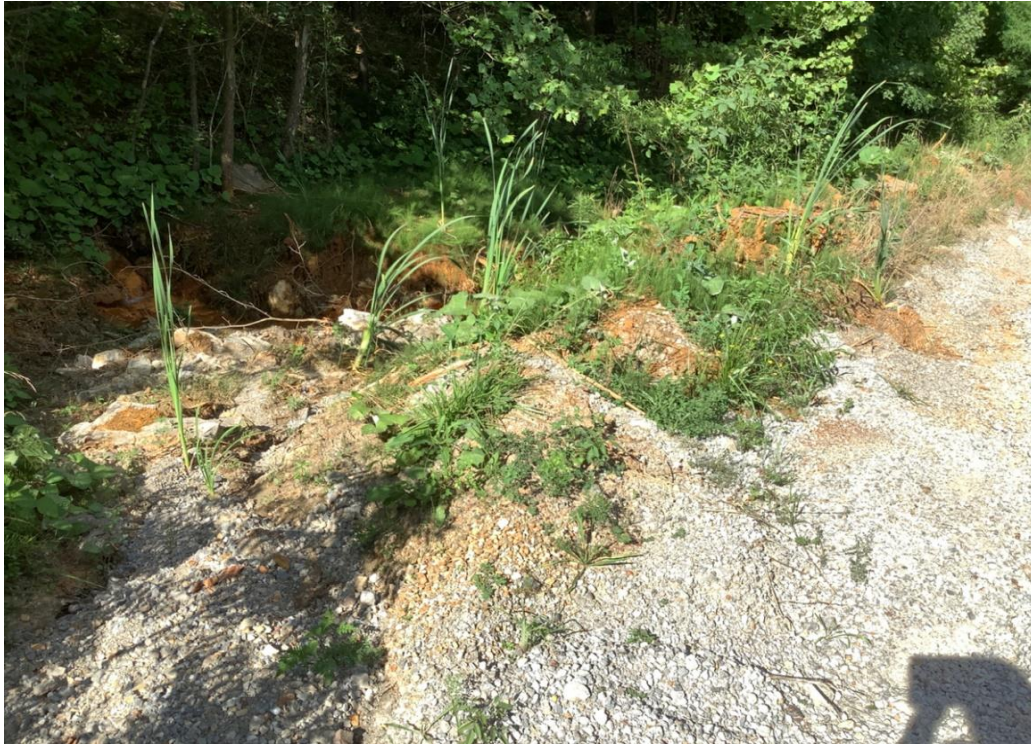
PHOTO 33: Spring with iron staining along the north side of Luther Jones Road, looking north.

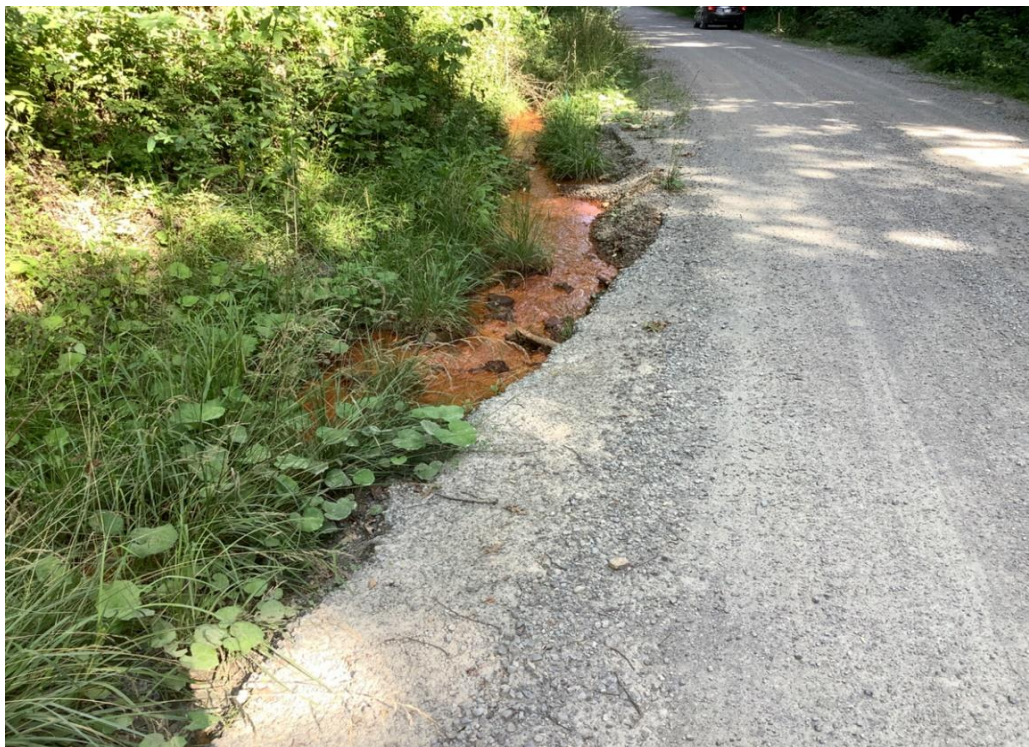
PHOTO 34: Flow from spring causing embankment erosion on north side of Luther Jones Road, looking east.

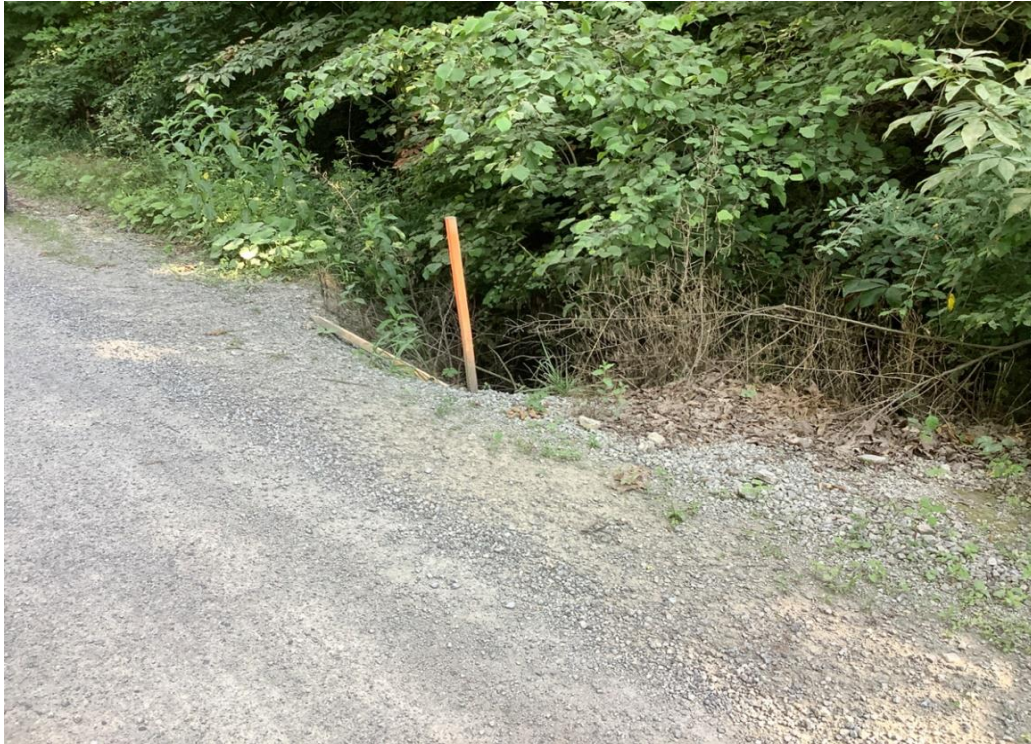
PHOTO 35: Localized embankment erosion on south side of pavement on Luther Jones Road, looking south.

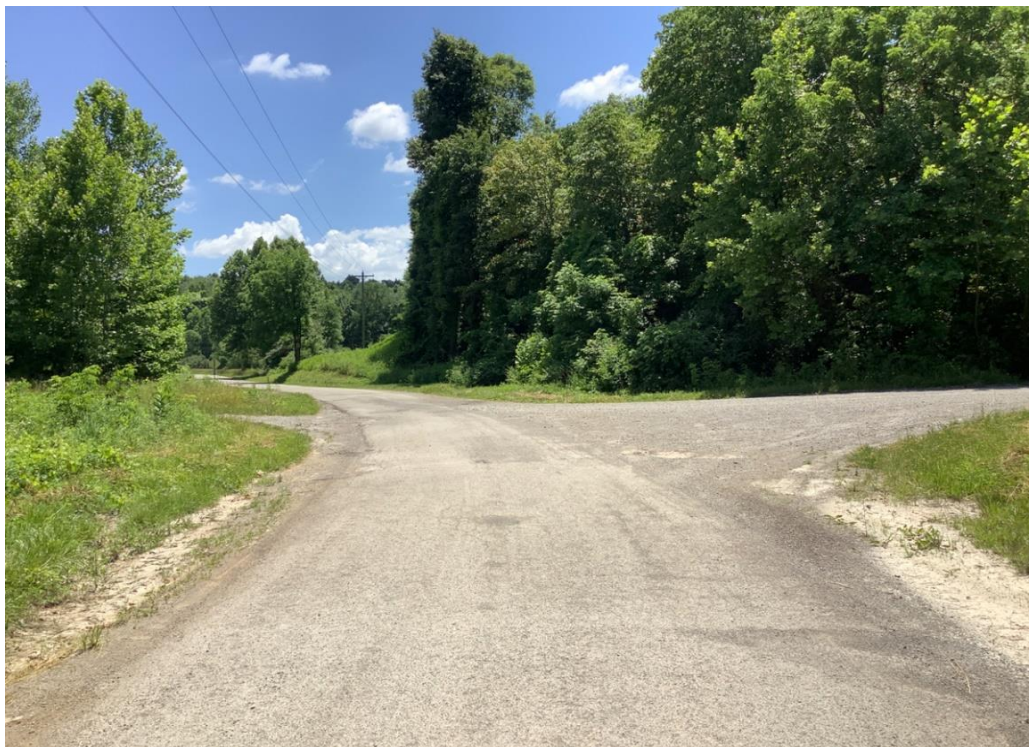
PHOTO 36: Intersection of Dixon Run and Luther Jones Roads, looking south.

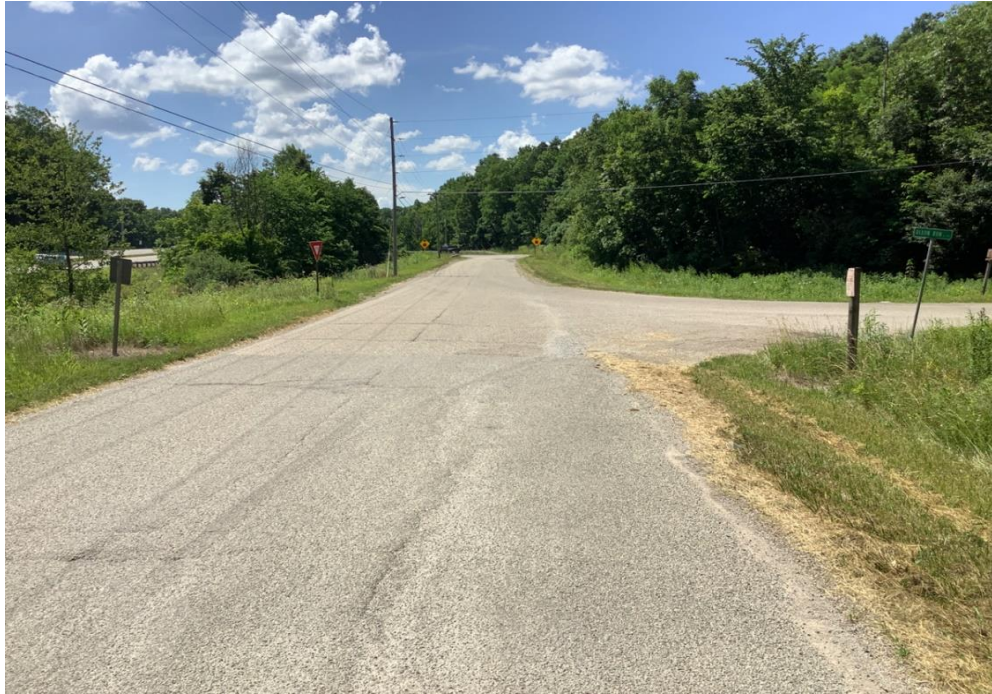
PHOTO 37: Intersection of Dixon Run and Vega Roads, looking west.

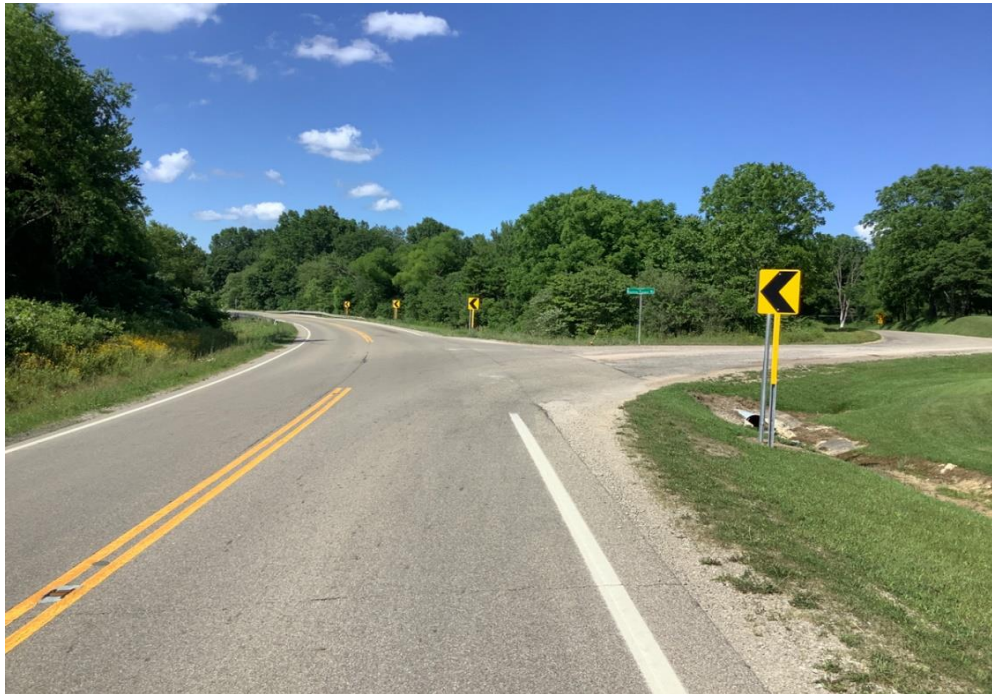
PHOTO 38: Intersection of SR327 and Keystone Furnace Road, looking north.

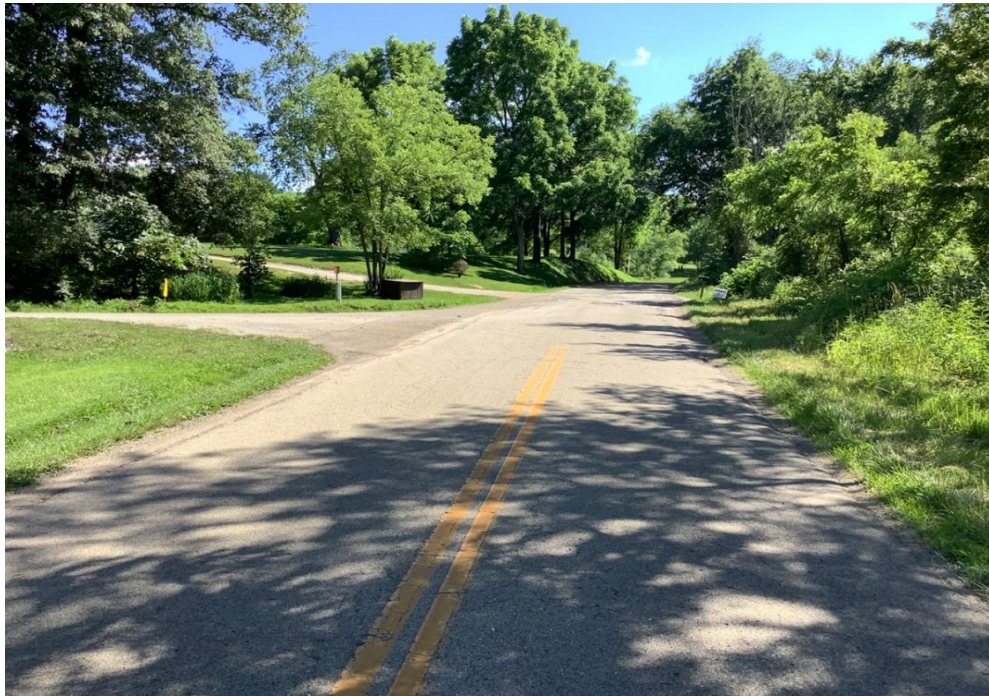
PHOTO 39: Intersection of Keystone Furnace and Luther Jones Road, looking south.
